SURVEY STATEMENT

Name of vessel:	BERGEN KREDS
Owner:	Redningsselskapet - Norsk Selskab til Skibbrudnes Redning
IMO Number:	9180322

Survey station:	Haugesund
Place of survey:	Langevåg, Hordaland(NOR,Norway)-Bømlo Skipperservice
Survey started:	2022-11-07
Survey completed:	2022-12-08
Lead surveyor:	Olsen, Frode Grindhaug
Surveyor:	Hagland, Yngvild Thyra; Bunes, Tørres Litlabø

Renewal surveys

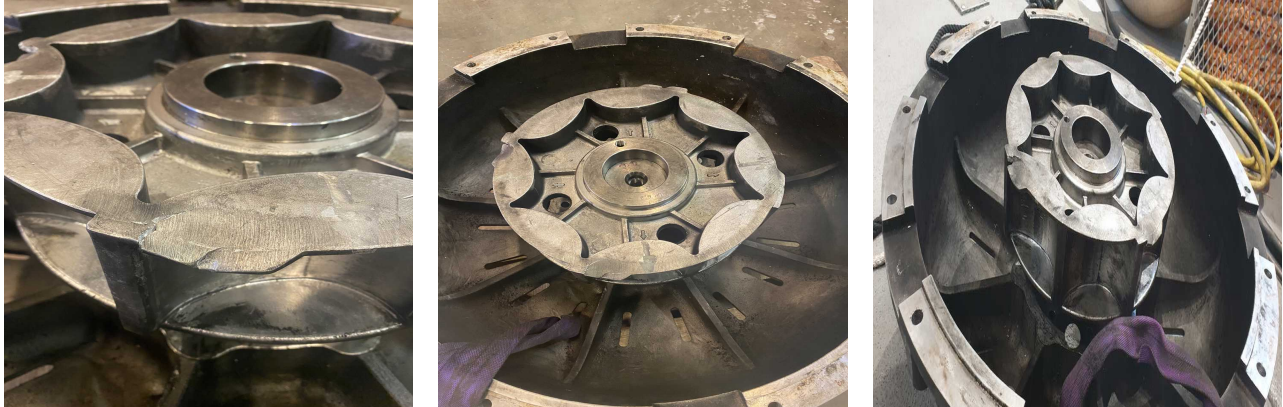
Propulsion torque and thrust transmission arrangement > Propulsion shaft coupling, elastic P (Pending)

Flexible coupling between port main engine and gear box damaged. During re-assembling after partial dismantling for inspection the spindle was damaged, resulting in cracks and deformation.

Damaged coupling has been grinded, welded and NDT tested. First repair attempt failed on NDT testing, and a second attempt was done with acceptable NDT testing result. As the part has gone through grinding and welding several times, this part are only accepted as a temporary solution until new part are received and mounted.
